ACCIDENT INVESTIGATION AT THE SWISS STEINGLETSCHER INSTALLATION

ABSTRACT

13. SUPPLEMENTARY NOTES See also ADM000767. Proceedings of the Twenty-Sixth DoD Explosives Safety Seminar Held in Miami, FL on 16-18 August 1994.					
14. ABSTRACT see report

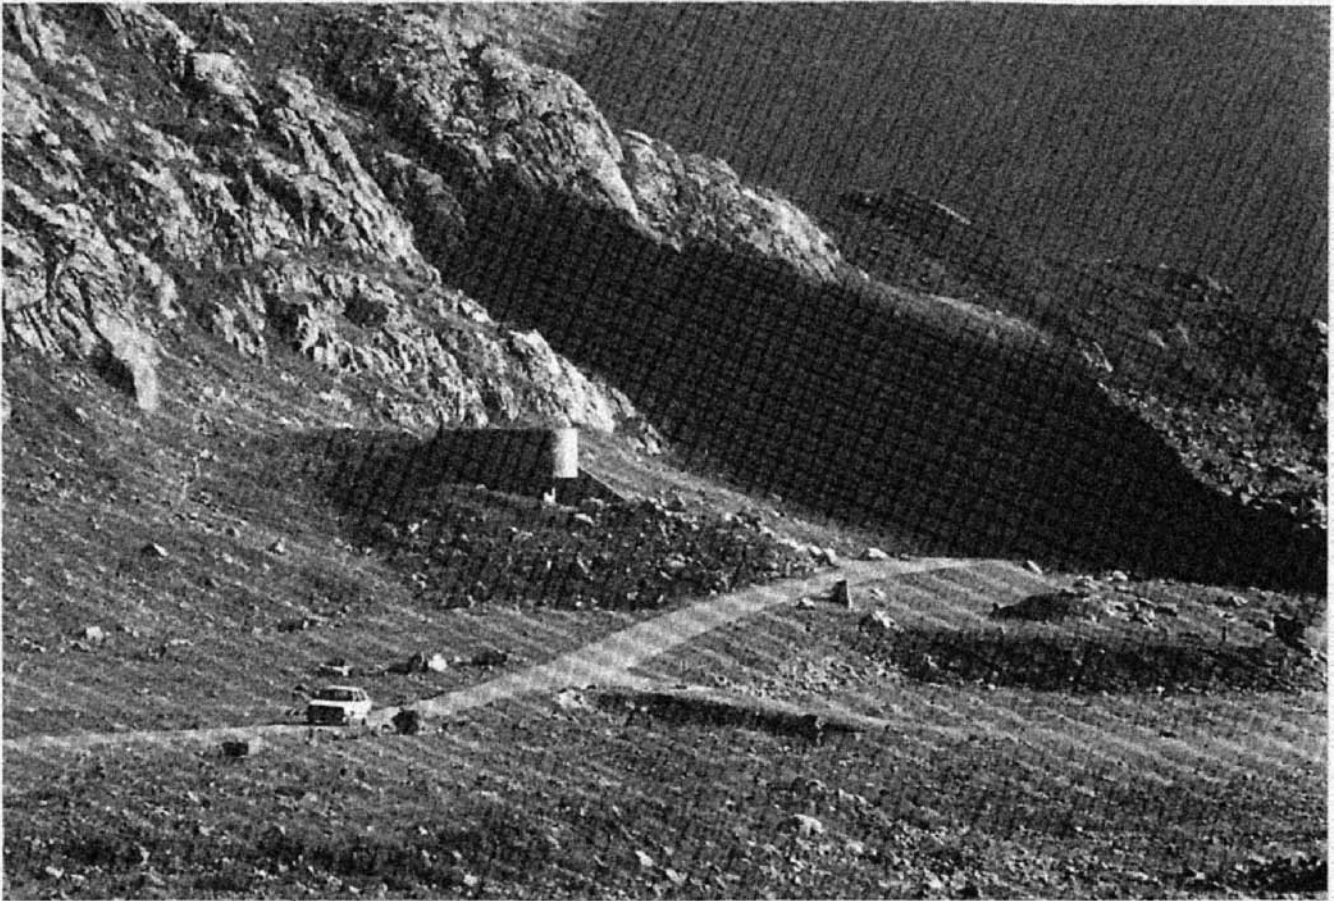
FIGURE 1.

Entrance Building before the Explosion

The accidental detonation of the Swiss munitions storage facility, Steingletscher installation shown Figure 1, provided a unique opportunity not only to the Swiss military authorities but also the US Air Force (YOX) to acquire real data from a full scale event. It should be pointed out that in Switzerland the safety of munitions storage facilities and handling of explosives in the military sector is assessed on the basis of a quantitative risk analysis approach (Kummer, 1993). The accident at the Steingletscher installation confirmed the applicability of the concept to such events. However, the technical data for the risk analysis, particularly, those of interest for the effect analysis, have been limited in its scope to a very limited amount of real information. Therefore, the mishap which was presented by the tragic event at the Swiss Alps was taken as an opportunity to extract maximum amount of real information from in order to improve the storage concept. As a result the Swiss Department of Defense personnel have been working towards full documentation of the filed data and event evaluation since its occurrence in the late 1992. More details on the Swiss safety concept was presented earlier (Bienz / Kummer / Swiss DoD, 1993). In general, positive experience was gained by the Swiss with their safety concept for the last two decades to the extend that several military and civilian agencies in the other countries adopted the approach with only minor modifications.

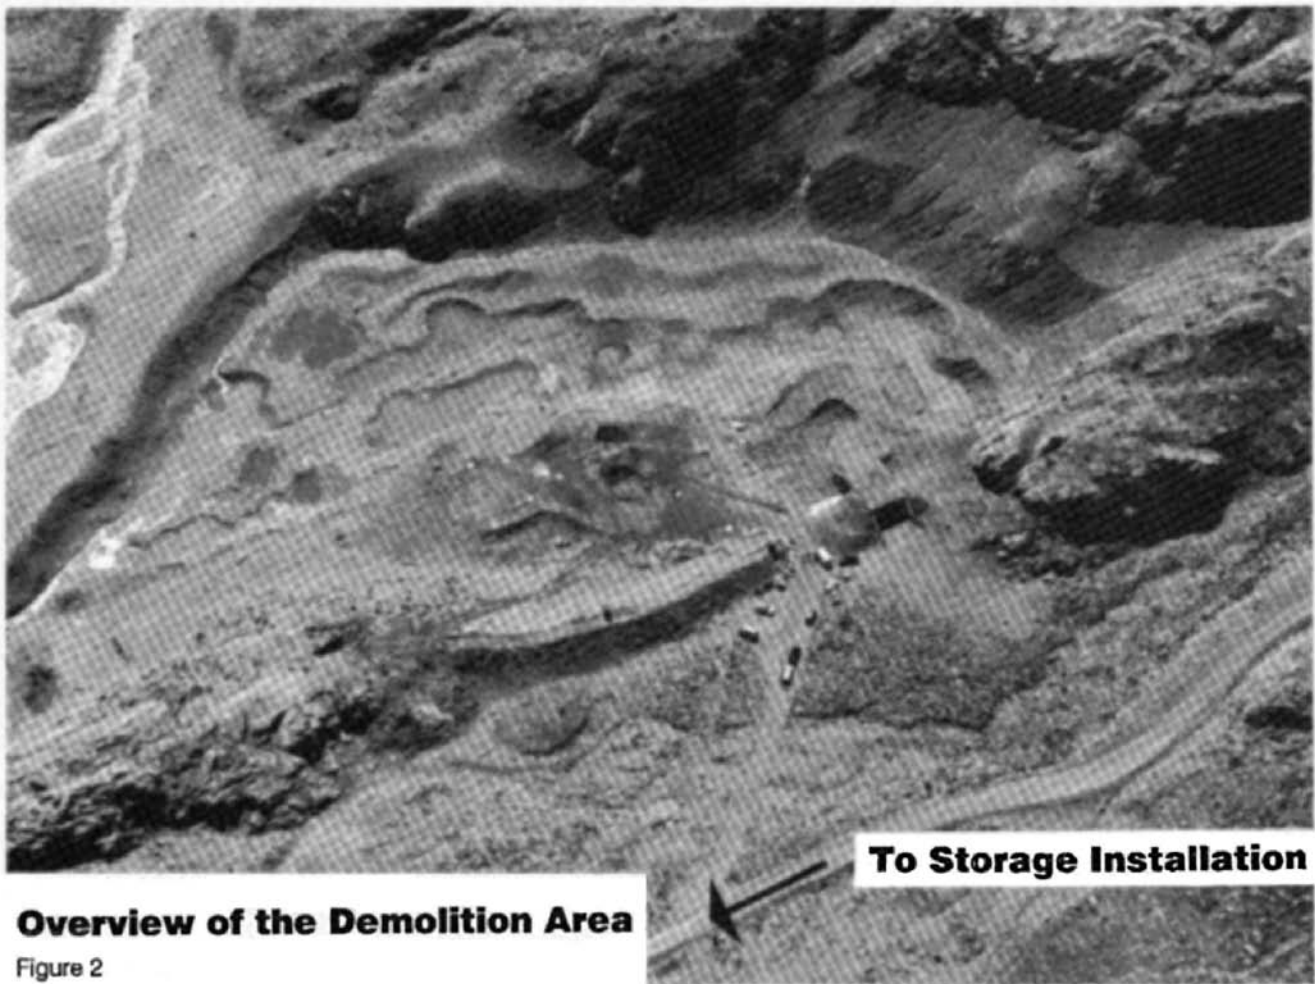
FIGURE 2.

Overview of the Demolition Area

The obsolete ammunition in Switzerland is disassembled by specialists in one of the ammunition factories of the Swiss Military Administration. Propellants and pyrotechnic materials are burnt, the explosive parts are transported to a disposal site in the Swiss Alps and detonated by trained personnel (Figure 2).

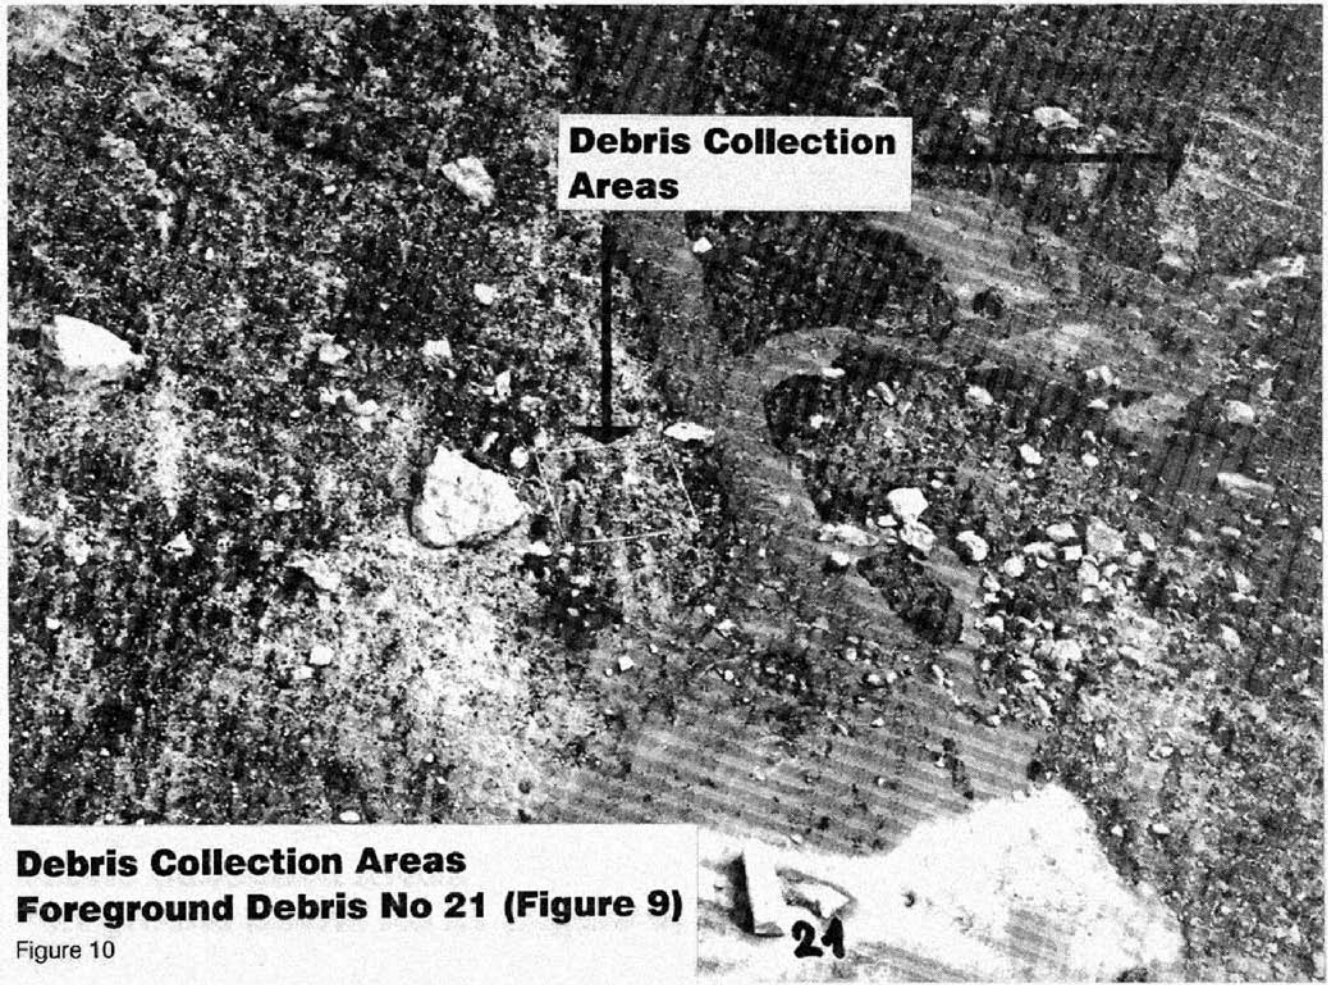
FIGURE 10.

**Debris Collection Areas
Foreground Debris No 21 (Figure 9)**

- Objects located (total of 53) were marked with white paint to ease their identification on the aerial photograph.
- Debris located were carefully measured for their dimensions and special features noted.
- Forty representative areas (20 to 150 m²) were selected and all debris which fall within these patches were recovered and their dimensional as well as their apparent characteristics were noted (Figure 10). The contrast which existed at the site between the background and blast-induced fragments facilitated the ease of debris identification during the recovery operations (Figure 11). The recovered debris are now being used to develop the debris density contour maps.
